Sarina Coastal Sustainable Landscapes Project

Campwin Beach

Protection and Rehabilitation of Sarina Beaches Coastline

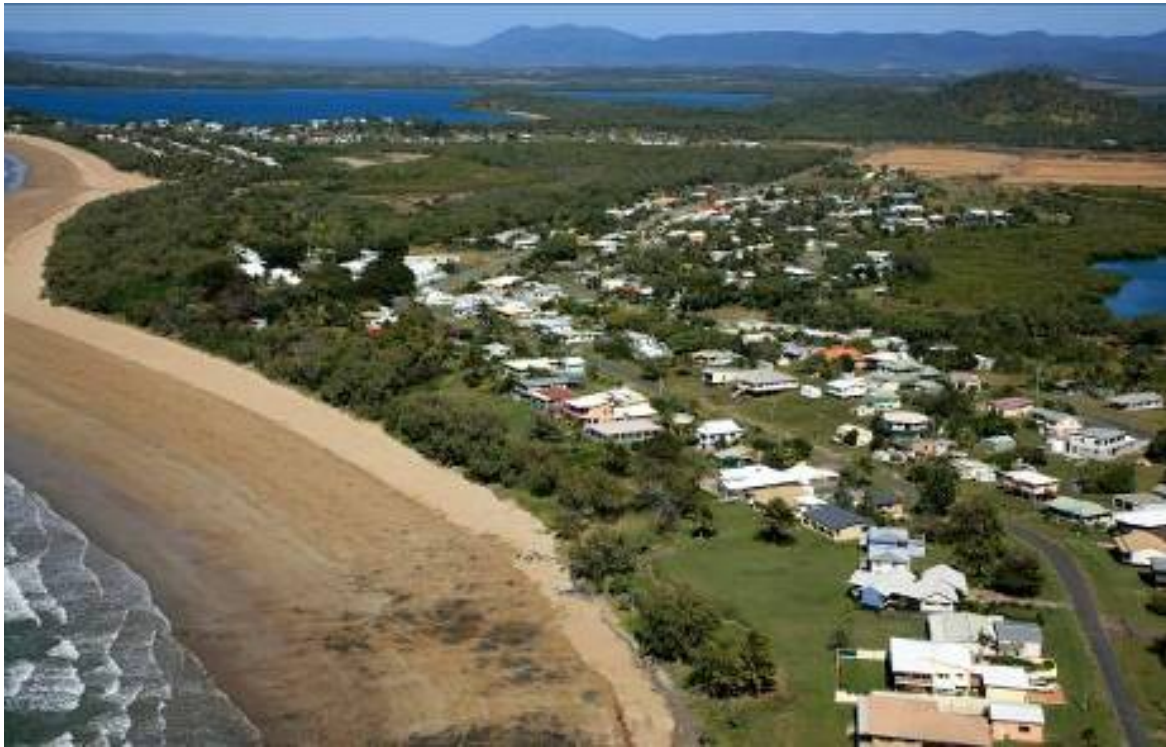
Figure 1a – Aerial Photo Zone A Campwin Beach Esplanade and dunes

The rehabilitation and enhancement plan applies to the coastal esplanade between the rocks of Leper Reef at the southern end and extends to the rocky headland at the northern end of the beach (refer to Figure 1a – Zone A). The project includes the council-managed Reserve for Beach Protection located between Sarina Beach and Campwin Beach which supports significant mangrove and saltpan (samphire) vegetation (refer to Figure 1b – Zone B).

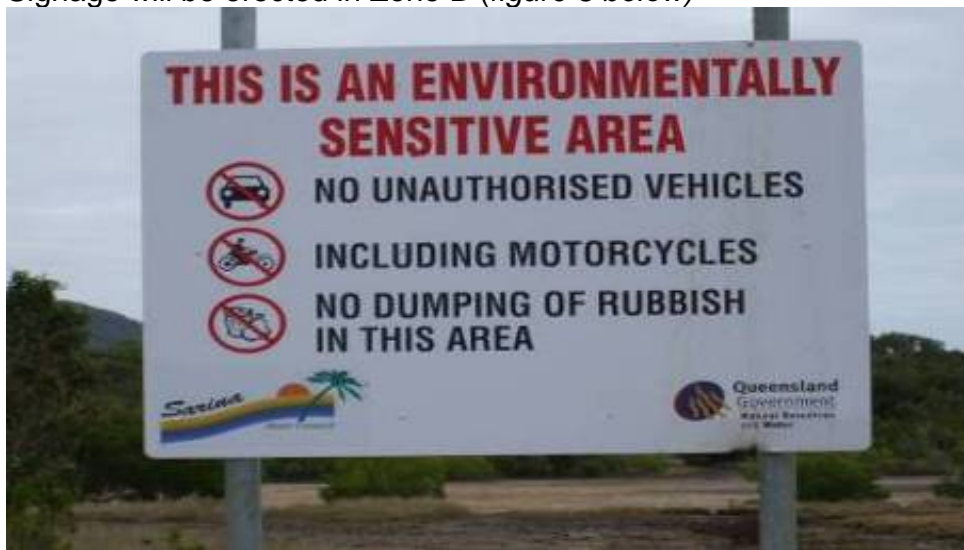
Figure 3 Environmentally Sensitive Area Sign

Zone B - A post and rail fence will be erected in strategic areas along the saltpan area south west of Campwin Beach to prevent unauthorized motor vehicle and motor cycle access to this sensitive area. Signage stating motor vehicles prohibited will be erected at all entrances to the saltpan. (see figure 3)

Signage will be erected in Zone B (*figure 3 below*)
